prugar
CONSULTING INC

There is Mold in My Attic !!!

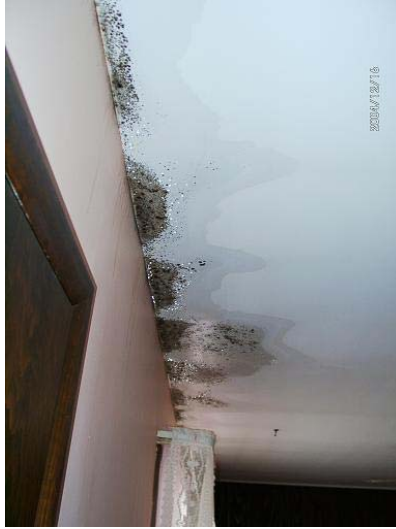
Figure 1 Mold growth and water droplets on ceiling.

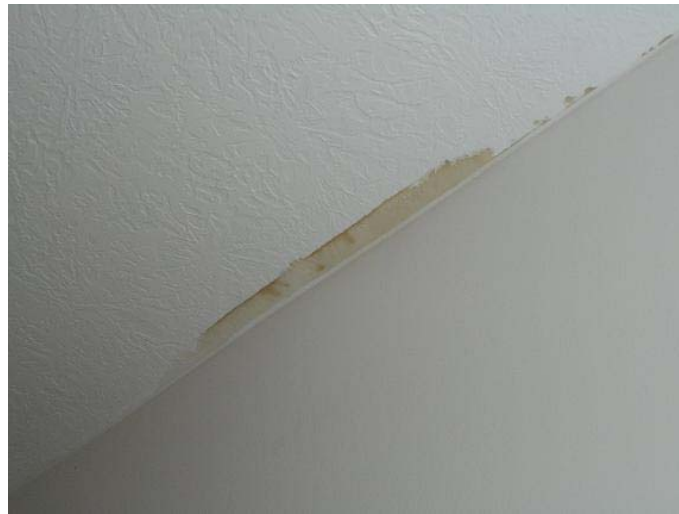
Figure 2 Tea colored staining on ceiling near the exterior wall.

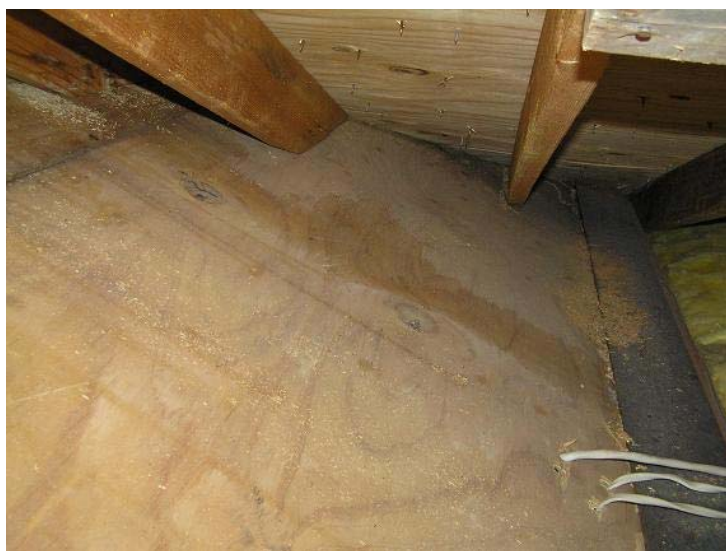
Figure 3 Roof leak at a valley.

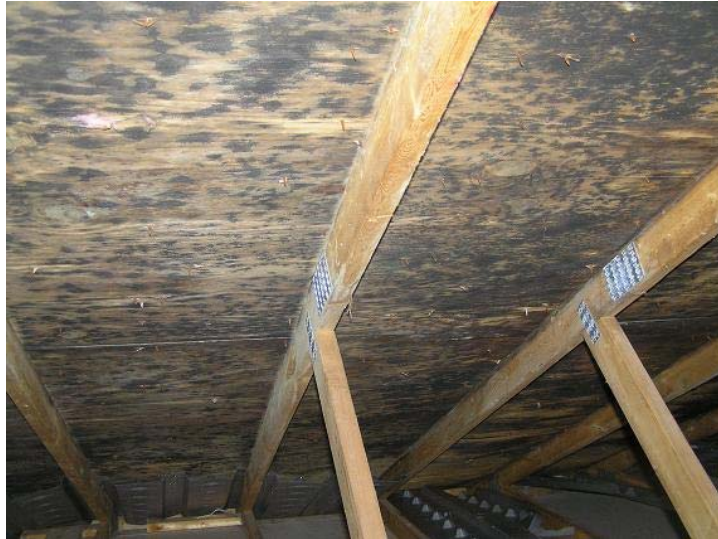
Figure 4 Widespread mold growth on underside of roof deck.

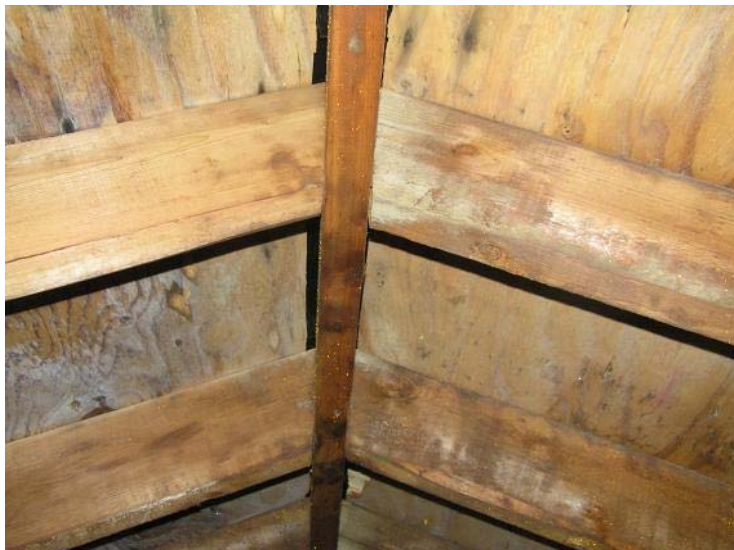
Figure 5 Air flow through ridge vent restricted by narrow slot and ridge board.

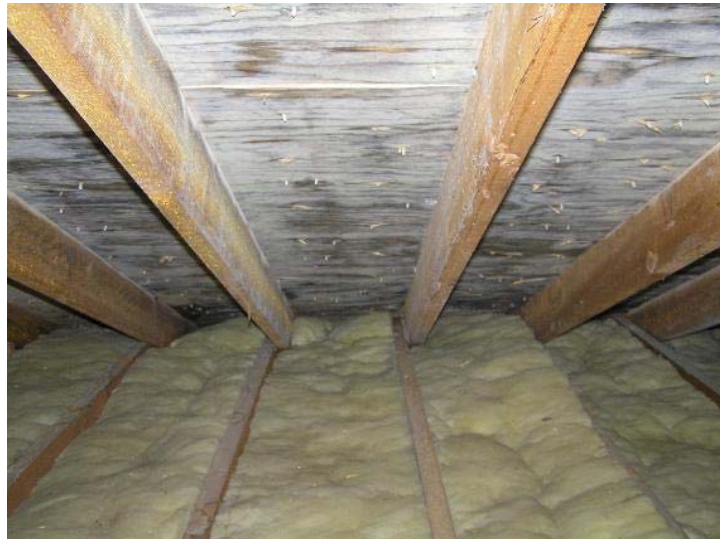
Figure 6 ventilation from eave restricted by insulation tight to roof deck.

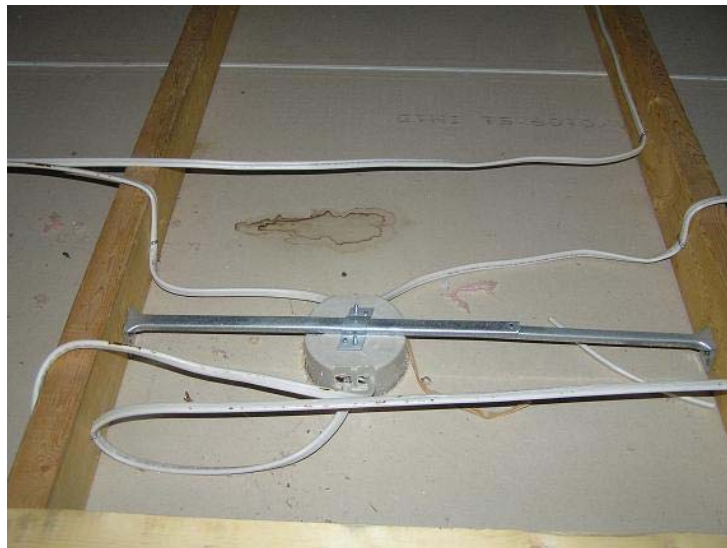
Figure 7 Moisture stain on top side of ceiling. Note multiple rings.

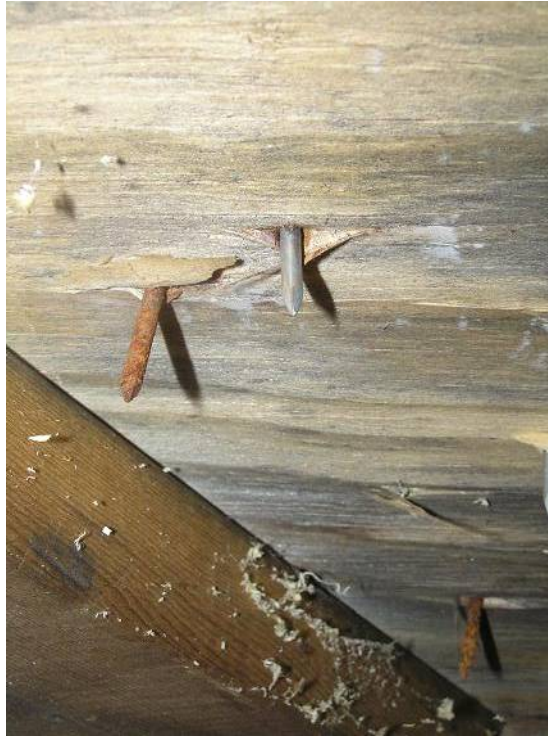
Figure 8 Corroded nails and clean nails present in the attic space.

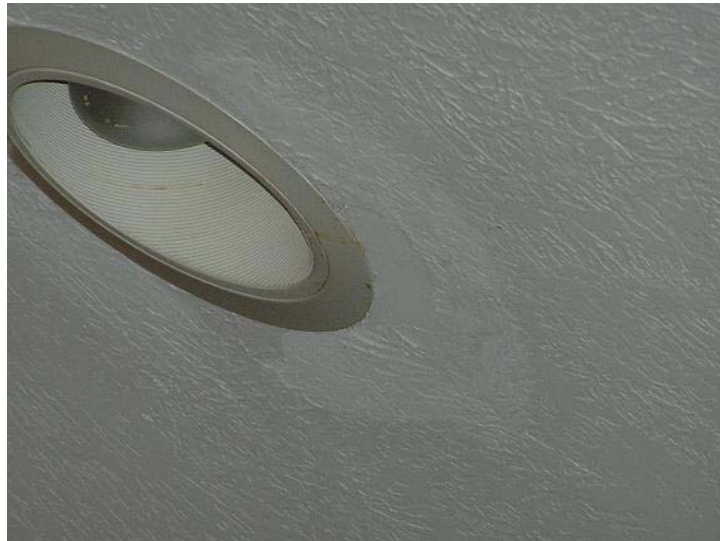
Figure 9 Previous paint coverage at area of moisture staining.

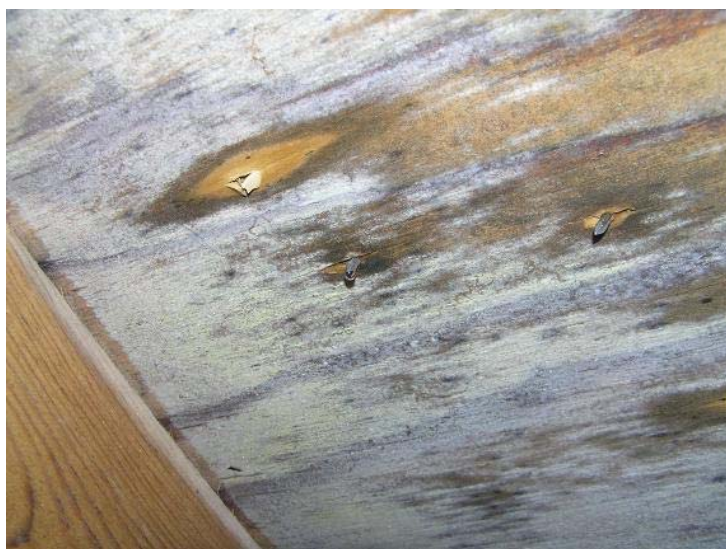
Figure 10 Roof deck clear at hole for removed galvanized roofing nail.
Roof deck is mold covered around newer roofing nails.
