A Primer on Basement Wall Distress

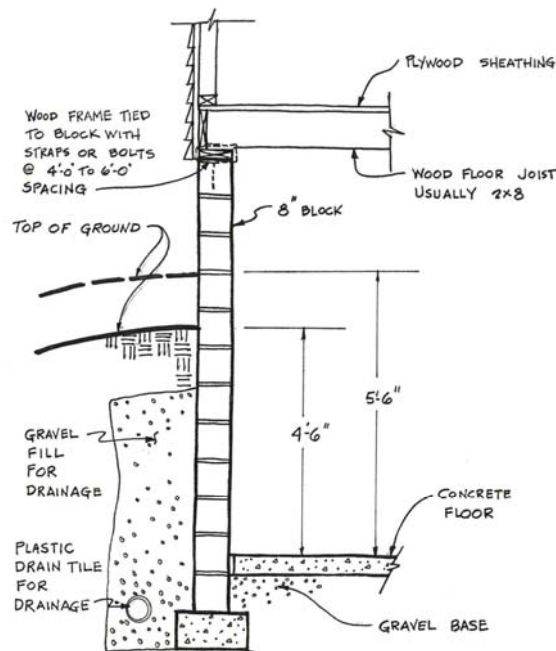
Figure 1 Common basement wall construction

Basement walls provide vertical support for the wood framing above (Figure 1). If the structure above, the contents in the structure, and the basement walls are too heavy for the soil under the footings or if the soil drops from landslide, consolidation of a fill material, shrinkage, etc., then the walls drop. When the dropping is not uniform, the walls are bent like a pencil or sheared like the tearing of a piece of paper.

Basement walls not only support the framing above they also retain the earth and groundwater from the basement area. A basement wall resists the inward pressures of the earth backfill and groundwater by spanning vertically between the basement floor and the wood framing above it (Figure 1). The backfill and groundwater behind the wall push inward as the basement floor and first floor framing hold the wall in place.

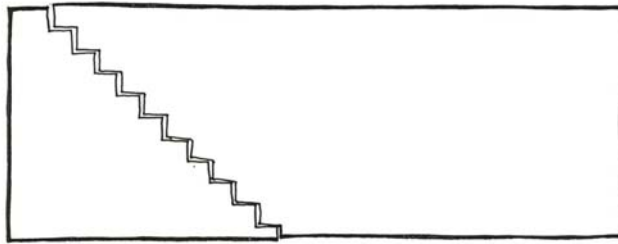
Figure 2 Common stairstep settlement cracking with cracking wider at top than bottom.

Cracking from earth movement can be vertical, horizontal or stairstep in pattern (Figure 2). When the outer ends of the wall(s) drop more than the center portions, the vertical or stairstep cracking is usually wider at the top than the bottom. If the center drops more than the ends, the cracking will be wider at the bottom than the top. Many times the vertical or stairstep cracking from uneven dropping will be evidenced by a vertical offset across the cracking. That is, the portion of wall on one side can be seen to be lower than the portion on the other side.

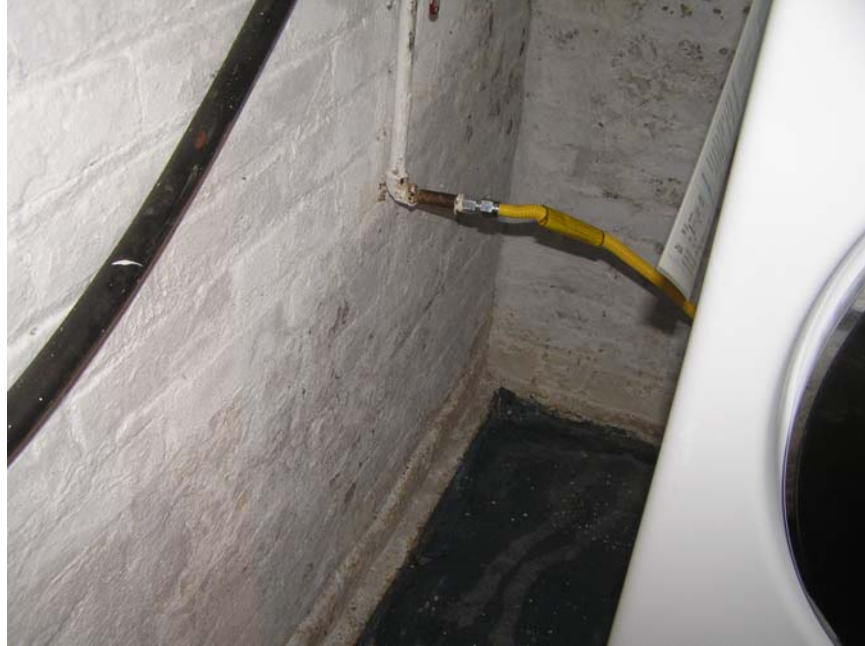
Figure 3 Interior face of wall exhibits staining, peeling paint, blistering of paint, mineral deposits, and repeated paint coverage.

When basement walls are retaining excessive amounts of groundwater, the interior face of the walls commonly exhibit moisture staining, mineral deposits (efflorescence), blistering or peeling paint, dampness, or seeping water (Figures 3 and 4).

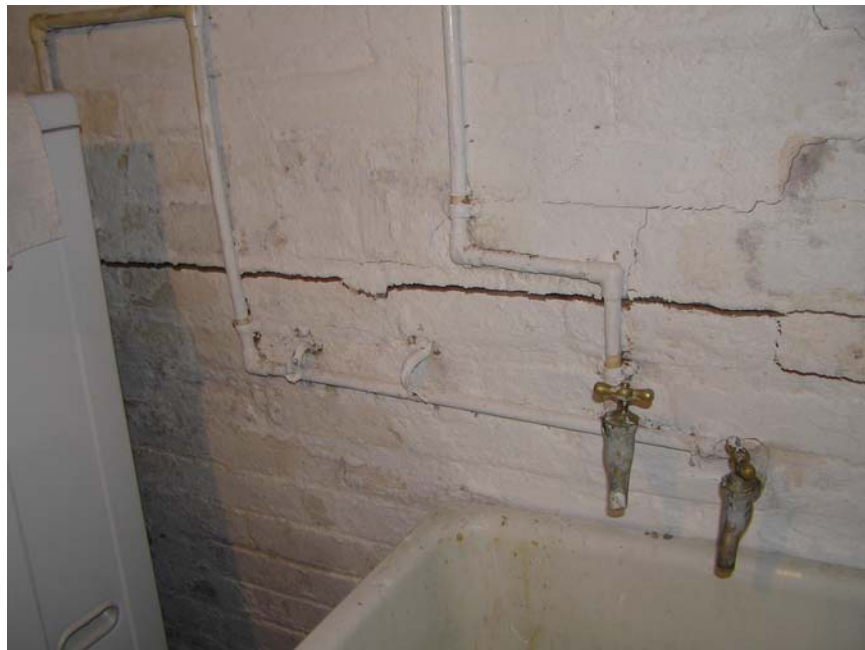
Figure 4 Interior face of wall exhibits staining, peeling paint, blistering of paint, mineral deposits, and repeated paint coverage.

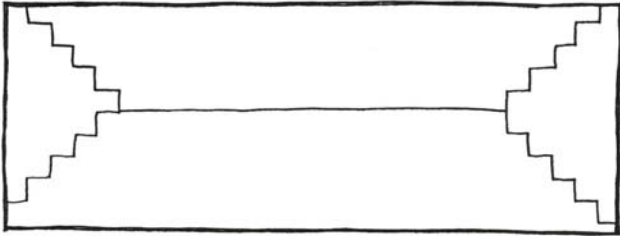
Figure 5 Horizontal cracking from inward bowing with stairstep cracking at ends.

When basement walls are exposed to excessive earth pressures and/or excessive groundwater pressures, they often exhibit visible inward bowing and cracking. Cracking from excessive inward pressures is usually comprised of horizontal cracking at or about mid-height of the wall: the ends of the horizontal cracking often extend up and/or down in a stairstep pattern where the horizontal cracking approaches the ends of the wall or an interior cross wall (Figures 5 and 6).

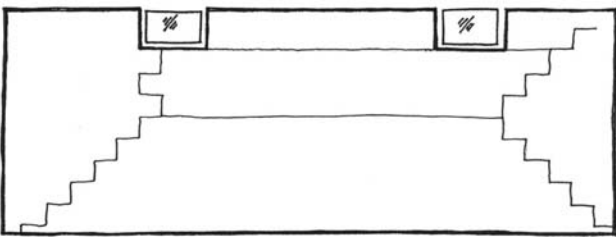
Figure 6 Horizontal pattern of cracking from inward bowing can be altered by window placement.

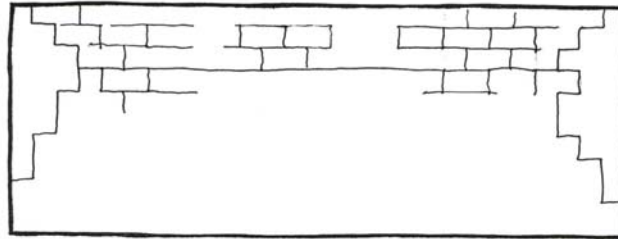
Figure 7 General pattern of extensive and widespread cracking near grade from surcharge pressures.

Basement walls damaged by surcharge pressures usually exhibit more severe damage than those damaged by excessive earth and/or groundwater pressures. That is, the cracking is more dramatic. A previously undamaged wall usually exhibits cracking in the mortar joints around nearly every block in the courses at or a few feet below grade (Figure 7). This is due to the high pressures generated by the soil being squeezed against the wall. A previously cracked basement wall will exhibit similar damage, but the pattern of damage will be modified by the relief of the pressures when the previously existing cracking opens.

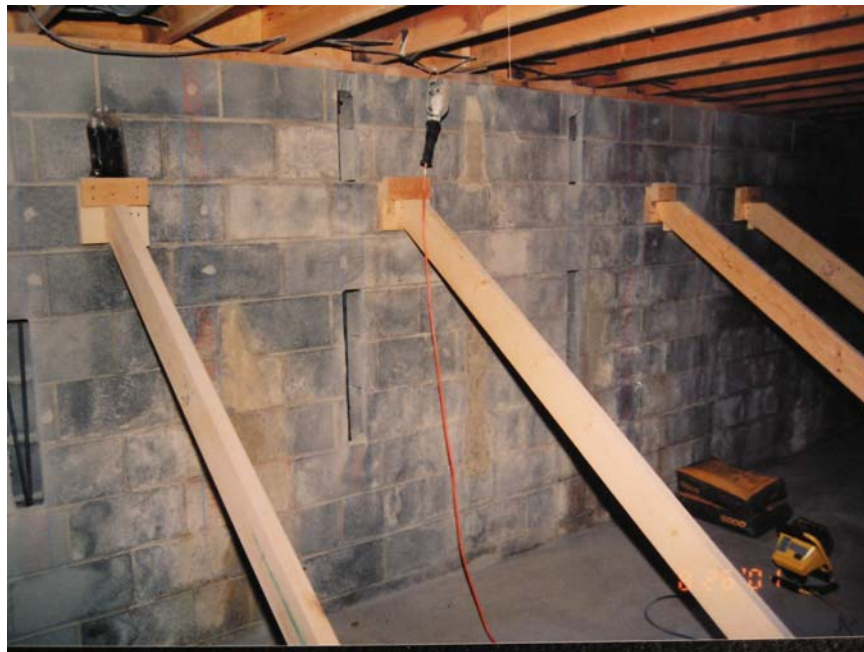
Figure 8 Slots cut for access into cores of block.

If the inward bowing is not excessive, basement walls damaged by excessive inward pressures may often be repaired by excavating behind the wall, allowing the wall to flex back into vertical position, reinforcing the hollow cells of the concrete block with vertical reinforcing rods and a concrete fill, and routing and repointing the cracked joints (Figures 8 through 10). If the inward bowing of the wall is excessive, the wall requires replacement. The foundation drainage system will also require replacement at that time. The details for these repairs may be determined by a qualified and experienced contractor or a structural engineer.

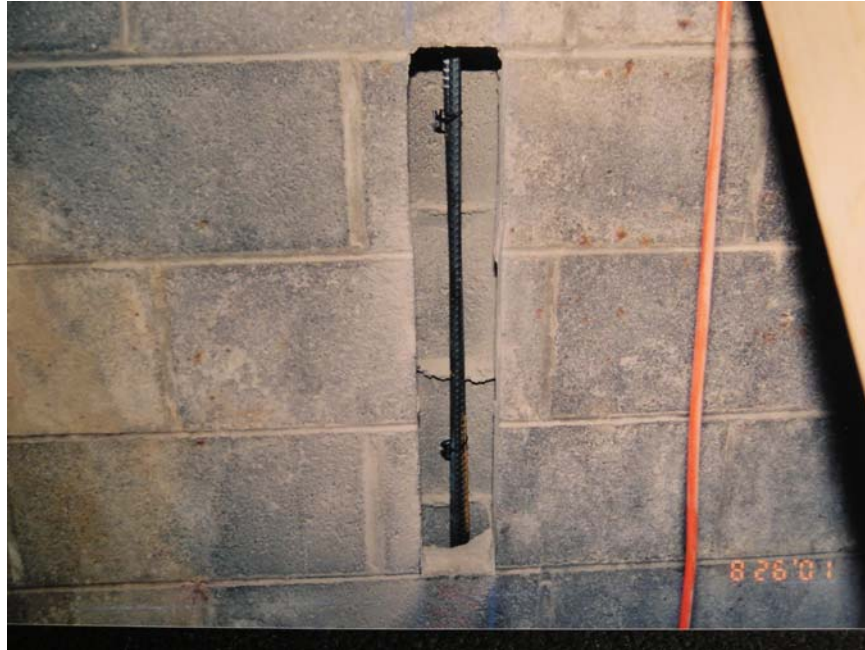
Figure 9 Steel reinforcing rods set in core. Note location and long lap.

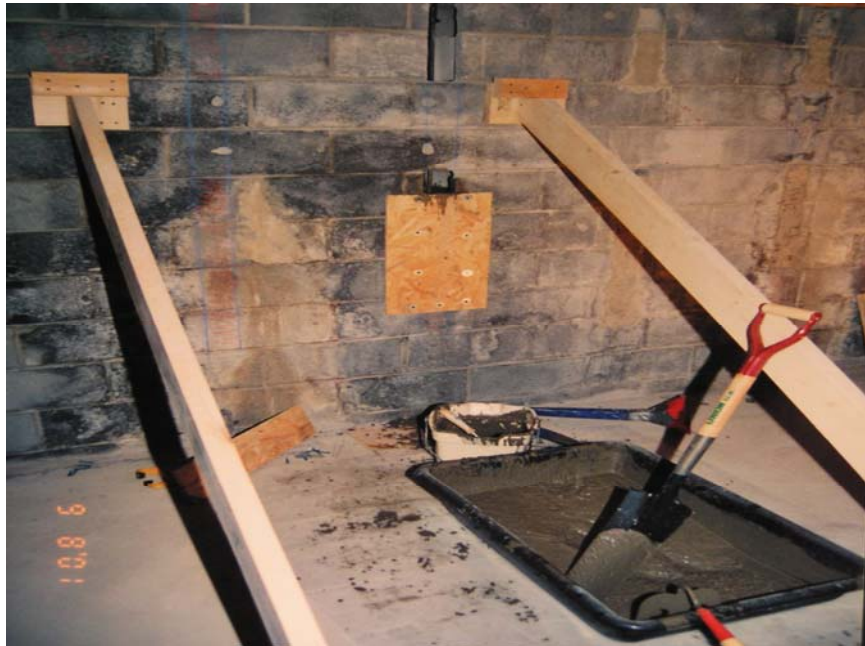
Figure 10 Slots covered and cores filled with relatively fluid concrete mix.
