**prugar**  
CONSULTING INC

## **My Roof Is Sagging!**

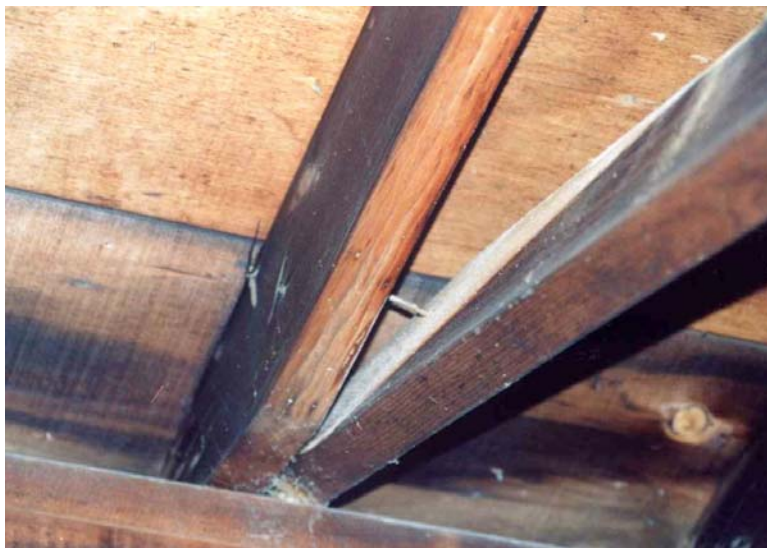
Sometimes the layout of the rafters and ceiling joists or rafter ties forms a proper triangle, but there is still sagging. In these cases the spreading of the rafters and the subsequent sagging is usually due to inadequate nailing of the ceiling joists or rafter ties to the side of the rafter. The 2006 edition of the Ohio Residential Code (and industry standards) recommend three 8d nails to fasten each ceiling joist or tie to the side of the rafter, three 8d toe nails (nailed at an angle) to fasten each ceiling joist or tie to the top plate of the wall, and two 16d toe nails to fasten each rafter to the top plate of the wall. Fewer nails than this will allow the connection to loosen and slip over time as the wood shrinks and swells.

**Figure 6 Ceiling tie fastened with one nail pulls away.**

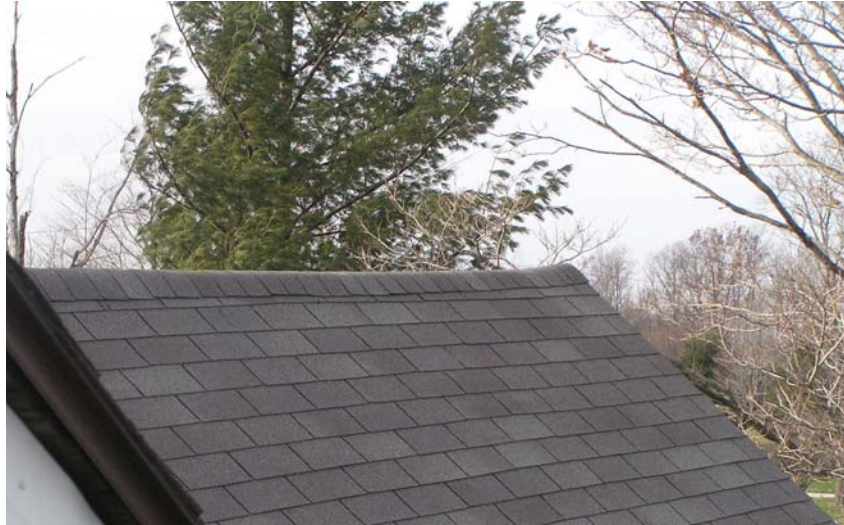
On the exterior, when the wall is pushed outward the rows of shingles will show an outward sweep (horizontal bow) with the wall. However, if the shingles are still in a straight line, the roof was bowed outward prior to the shingles being installed. Furthermore, if the shingles

exhibit an uneven exposure, that is, the shingle appears wider at the sides of the roof than at the center in one or more of the rows, the roof was bowed outward and sagged prior to the shingles being installed (Figure 7).

**Figure 7 Shingle exposure varies exhibiting sag in roof.**

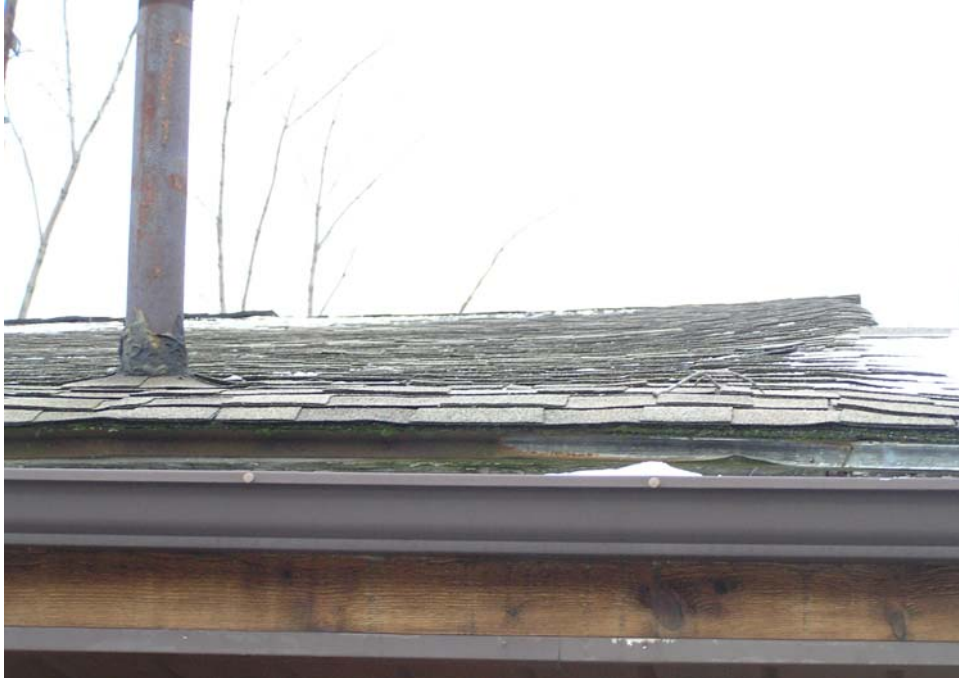
If the sagging appears in the plane of the roof, that is, up and down between the ridge and the eave and from side to side, the sagging is probably due to deflection and creep of the rafters themselves (Figures 8 and 9). Deflection is the immediate sag produced when an object is set on a structural member. For example, it is the sag in the board that spanned the creek when Dad walked across it – he was just a little too heavy for that board. But when Dad stepped off the board, it popped back up. Creep is the permanent sag in the board when an object rests on the board for a long time. Creep is caused by the stretching and adjusting of the wood fibers to the sustained weight on rafter (shingles, sheathing, drywall, insulation and rafters). Creep develops over years. A common example of creep is the sag in a cheap wood bookshelf. When books are set on the wood shelf, it sags slightly. If the books are removed after a short time, the shelf returns to a level position. However, if the books remain on the shelf for a long time, the sag increases, and when the books are removed, the shelf does not return to its original, level position. The permanent sag is from creep.

**Figure 8** Roof sags from eave to ridge.

Industry studies show that a relatively short term weight of snow and ice (up to four months) does not cause a permanent sag without fracturing some rafters. Studies also show that the amount of sag from creep is increased by the variation of moisture content in the wood framing and high stress in the wood. The variation in the moisture content of the wood is increased by inadequate attic ventilation. High stress in the rafter is usually due to using undersized rafters.

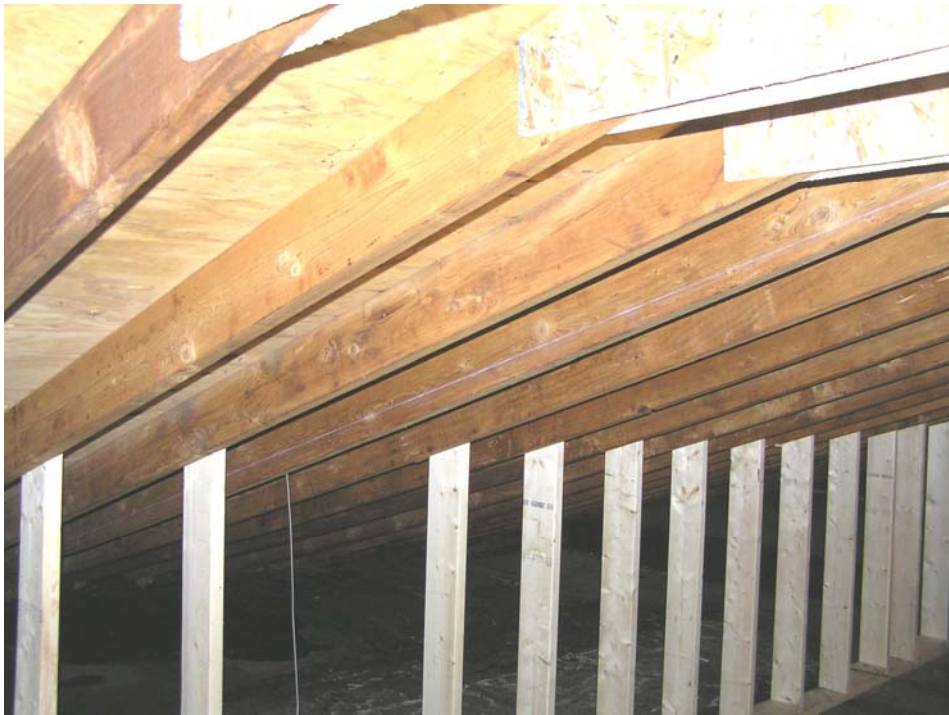
**Figure 9** Chalk line on side of rafter shows amount of sag.
